Brief guide to the SAAB 9000

1.0 Introduction and origins

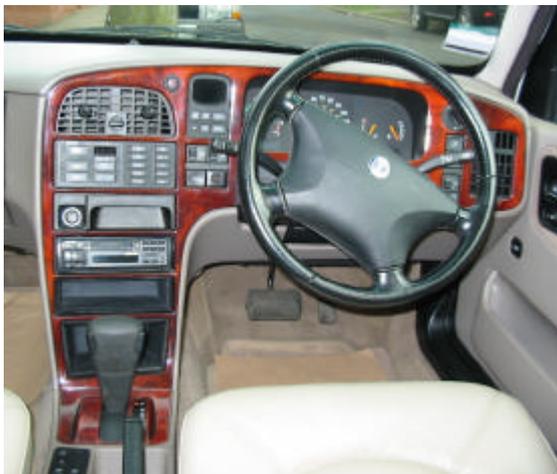
Below Left: CSE fascia layout is little changed from earlier cars but note airbag equipped steering wheel. The luggage boot (Right) can be made larger still by folding the rear seats.

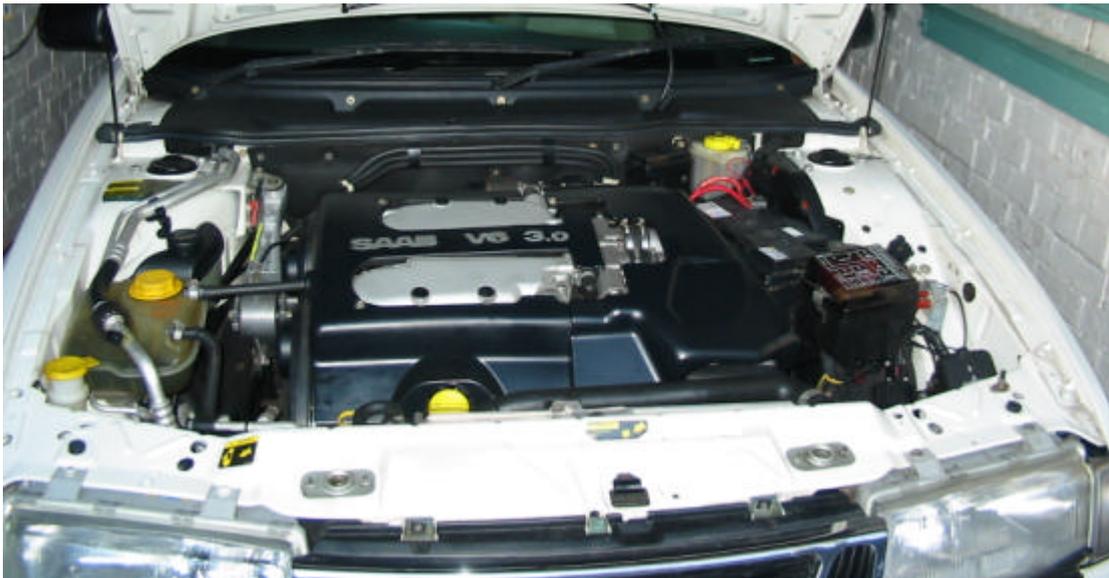
Below. the GM V6 (B308) engine installed in a 9000 CSE

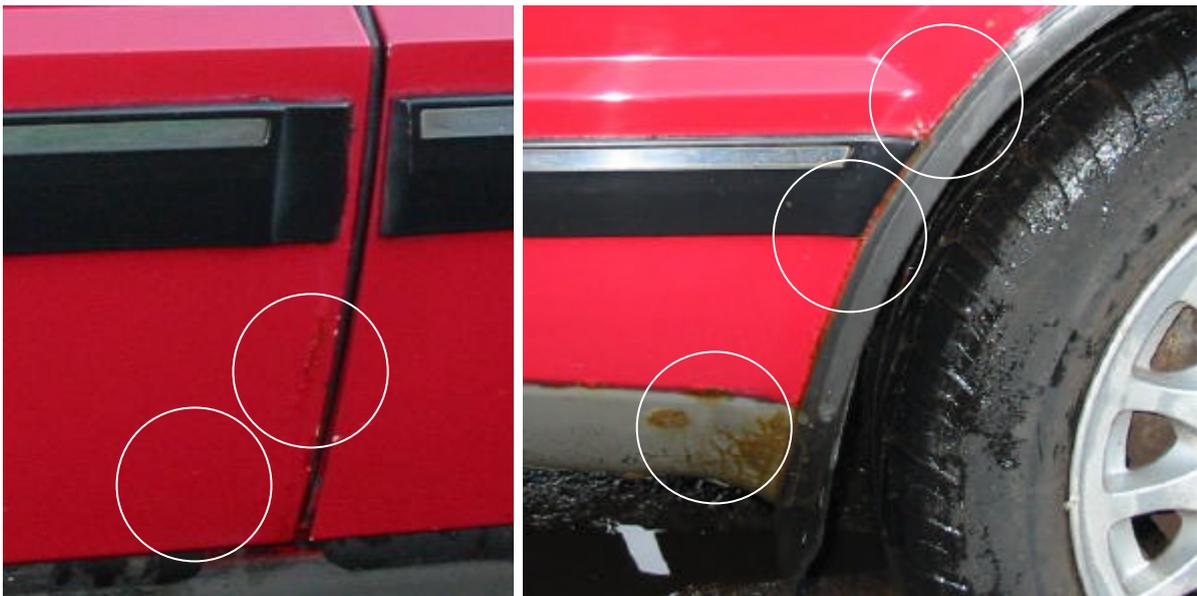
Above: check ALL models for rust blisters in the door bottoms (Left) and the rear wheel arch bottom aft of the rear wheel where mud collects. Circled areas are rust 'hot spots'.

Rust should not be a serious worry and checking is easy. Much of this is common sense - avoid anything with really tatty bodywork: stone chips are a sign of honest work but rust spells neglect and possible poor quality body repair work after an accident. Earlier pre-1990 cars can suffer from serious rust in the roof panel, especially if a sliding sunroof is fitted, so check carefully for any signs of bubbling or blistering because an effective repair is time-consuming, ergo expensive. . Doors on pre CS models too can suffer to the point that the bottoms can resemble lace curtains. This is often due to water being trapped in the door bottoms, sometimes due to blocked drain holes. Repair is possible but please note that the drillings for the fasteners for the body mouldings vary between considerably between variants and check strap design varies if used doors are to be acquired! This means that later CS doors can't be fitted easily to flat front models without work.

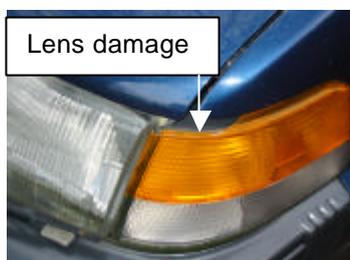
Left: check the top leading edge of front indicators on CD models/facelift hatches for damage

Headlamp lenses are not cheap but are at least available although second-hand ones can cost up to £30 each. With CD models and facelift pre CS hatchbacks (1991-2) do check that the top leading edges of the combined front indicator sidelamp units have not been damaged by careless closing of the bonnet.
